LOCATION: VA HOSPITAL BUILDING 14 - WEST HAVEN, CT/FIRST FLOOR

SEQUENTIAL REPORT OF LEAD PAINT INSPECTION FOR:

ASBESTOS SURVEY SUMMARY PLAN

Representative Photographs of ACM

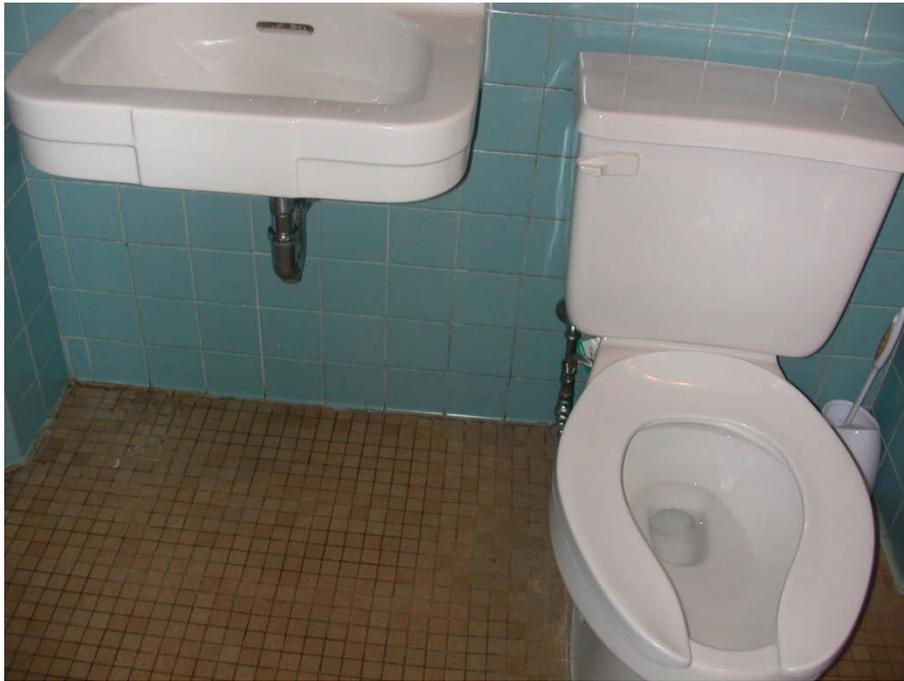
Flooring Caulk
Sample 3A

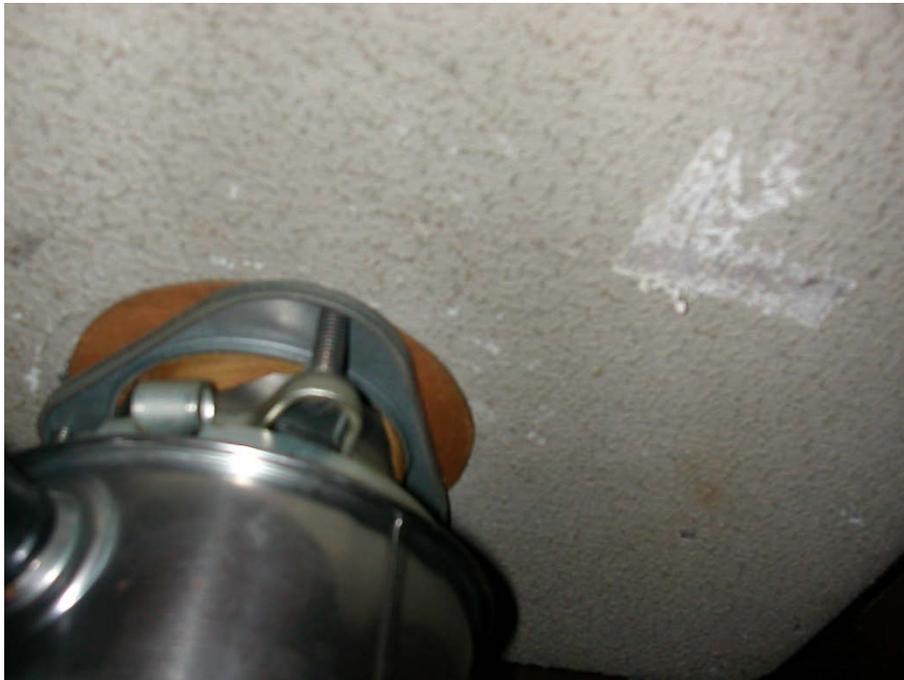
Sink Under Coating
Sample 8A

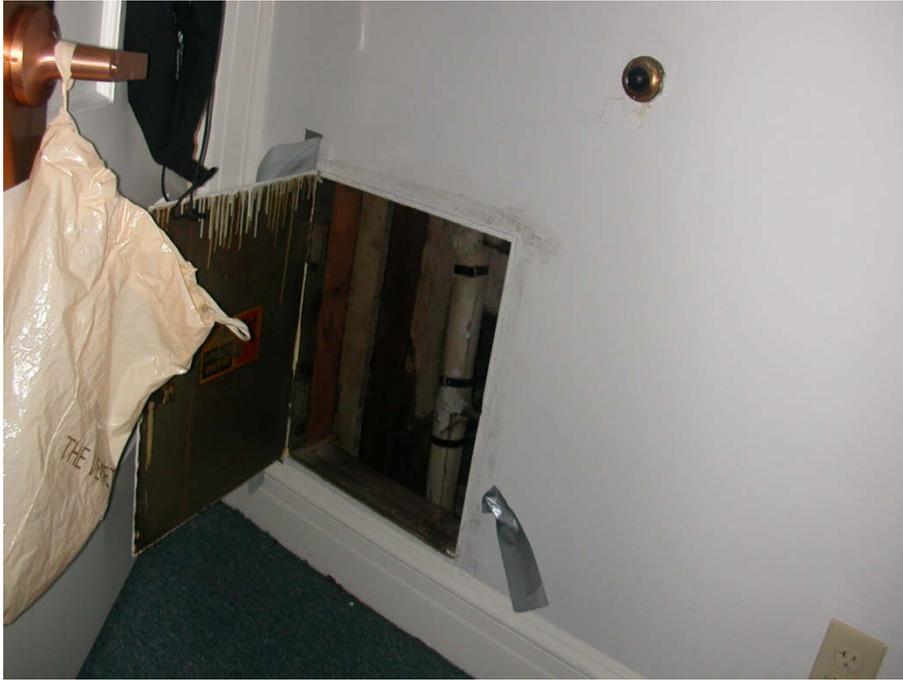
Pipe Joint Insulation
Sample 9A

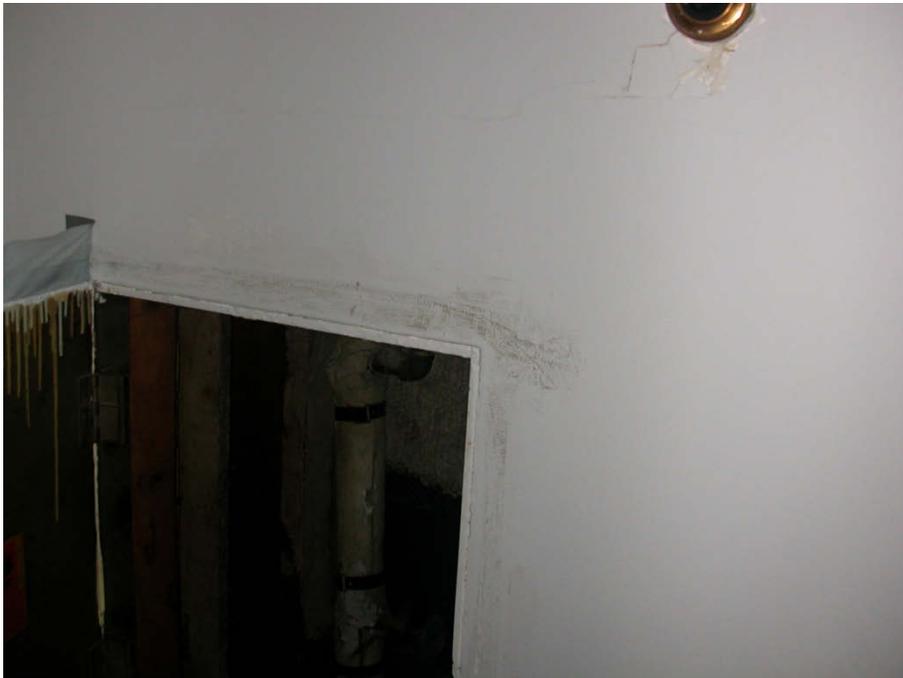
Corrugated Pipe Insulation
Sample 12A

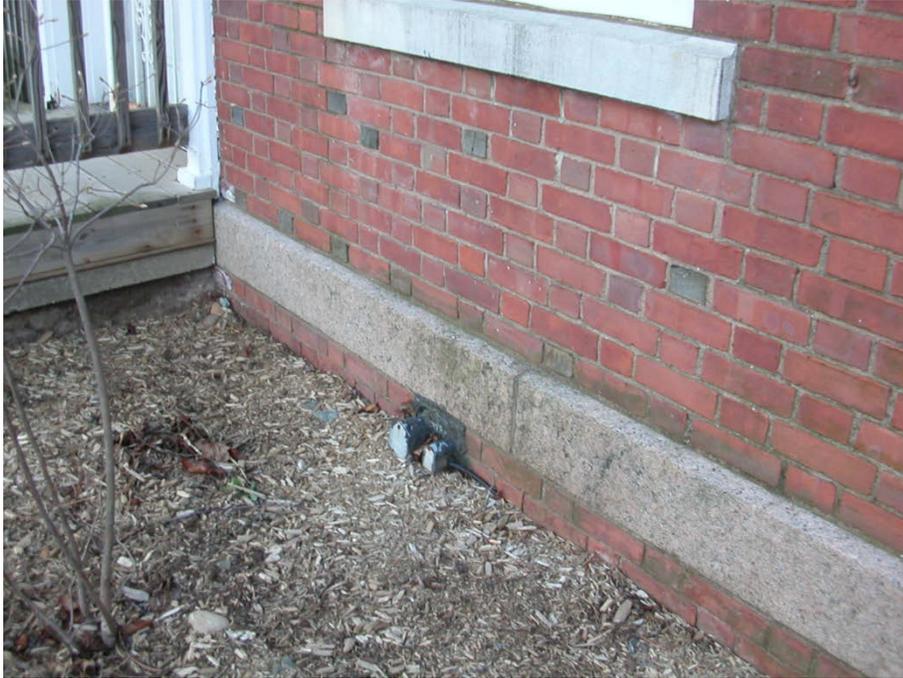
Black Electrical Conduit Caulk
Sample 29A

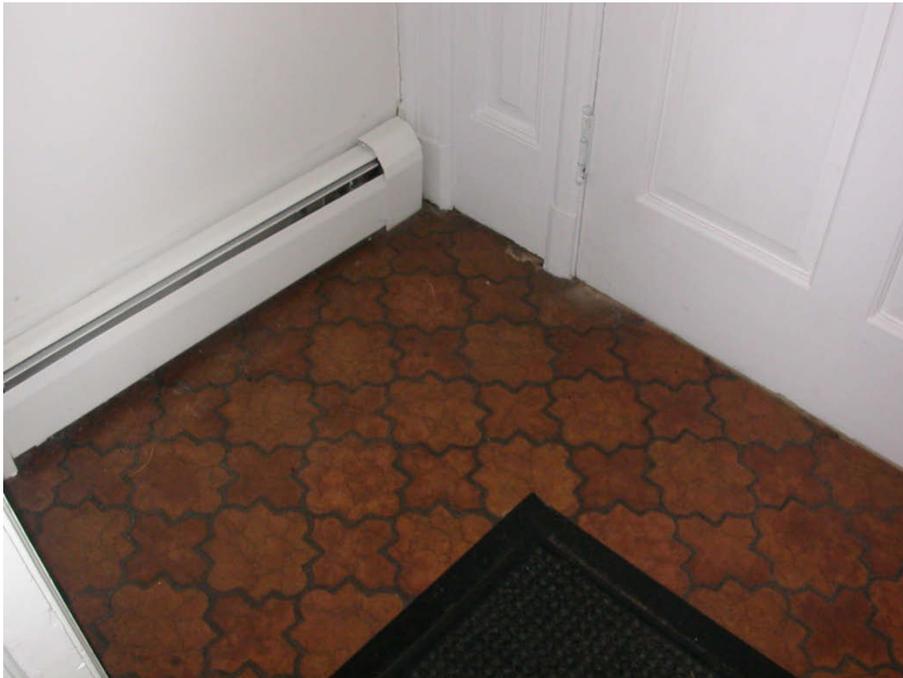
Brown Moroccan Linoleum
Sample 35A

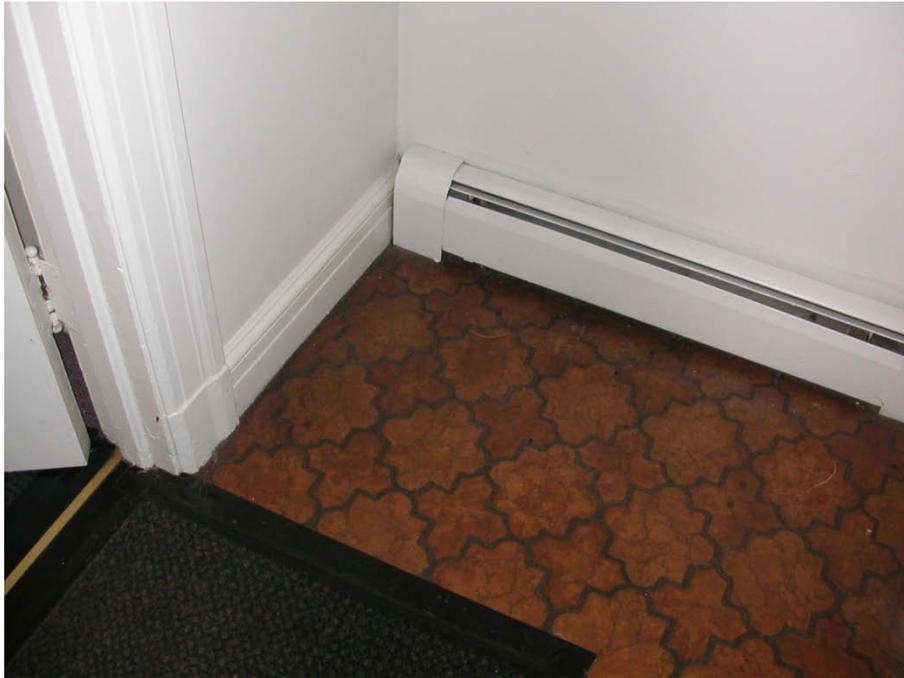
36A	102	102 Foyer	Felt Under Linoleum	20% Chrysotile	Good	70	SF	4
36B	102	102 Foyer	Felt Under Linoleum	Stop Positive - See Sample 36A				
36C	102	102 Foyer	Felt Under Linoleum	Stop Positive - See Sample 36A				
Footnotes: NAD - No Asbestos Detected (PLM)			SF - Square Feet LF- Linear Feet EA - Each					
<p>* - The VISN 1 hazard assessment scale 1 – 4 is a relative indicator of the risk and need for response/remediation. (1) represents the highest priority (e.g. removal or encapsulation) whereas a (4) represents the lowest priority (monitor as part of 6 month O&M program). The rating, assigned by an Asbestos Management Planner, takes into account the following criteria: condition, friable vs. non-friable, accessibility, occupancy (e.g. continuous, intermittent or occasional, patients/staff/visitors), potential for air erosion, potential for vibration damage, potential for disturbance/damage (e.g. exposed and in an accessible location), and potential for water damage.</p>

Felt Under Linoleum
Sample 36A

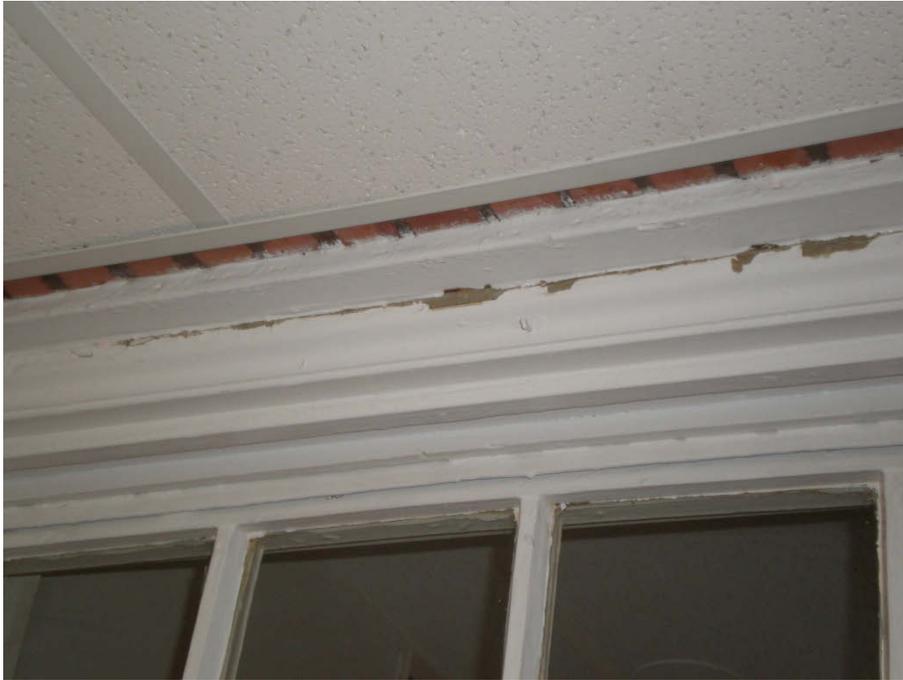
Metal Window Lintel
Sample 2175

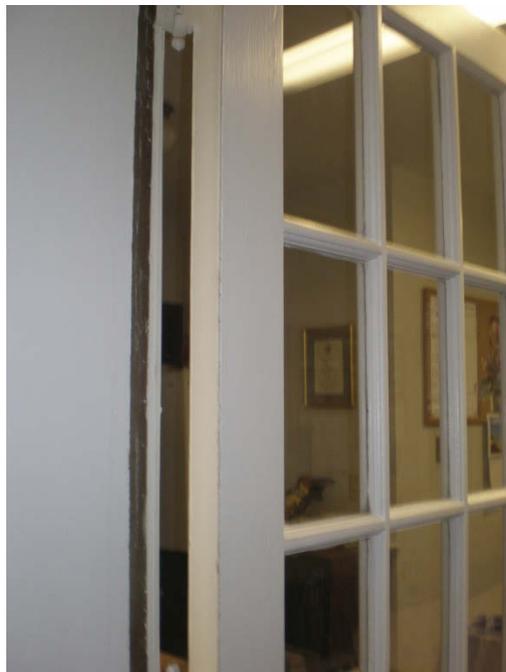
Wood Door
Sample 2180

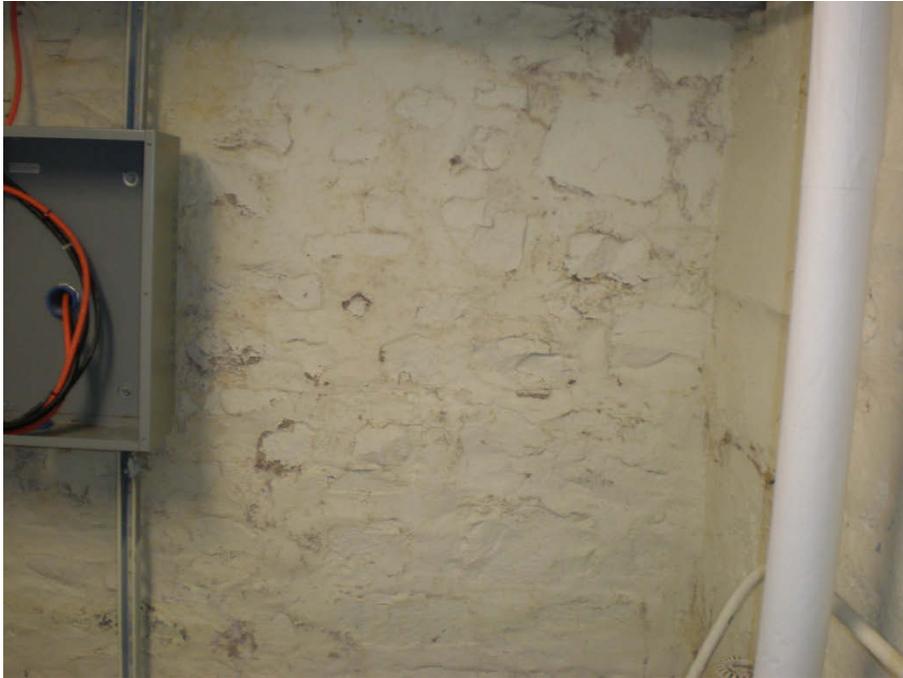
Stone Wall
Sample 2315

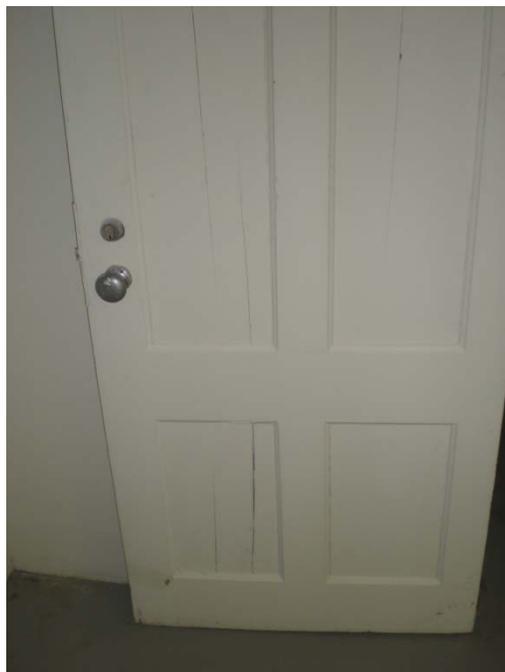
Wood Door
Sample 2332

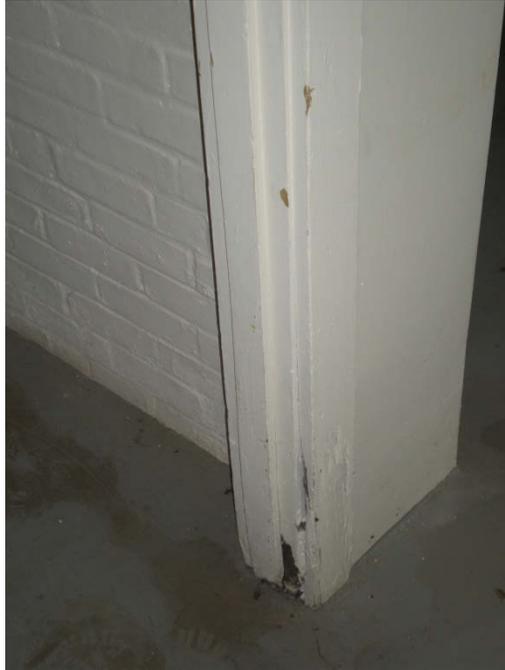
Wood Door Casing
Sample 2333

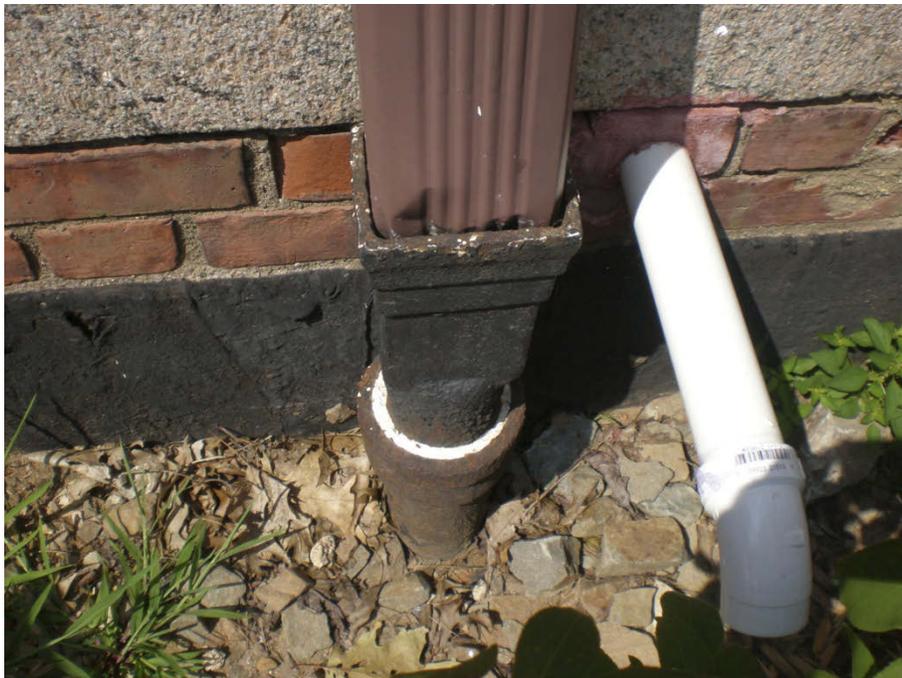
Metal Downspout
Sample 2366

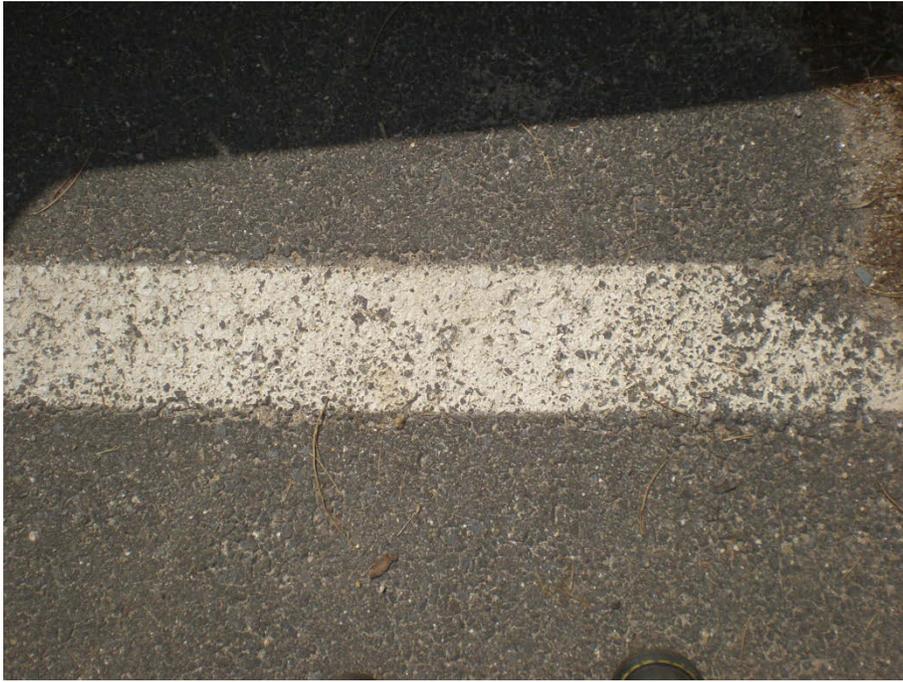
Asphalt Walk Stripe
Sample 2369

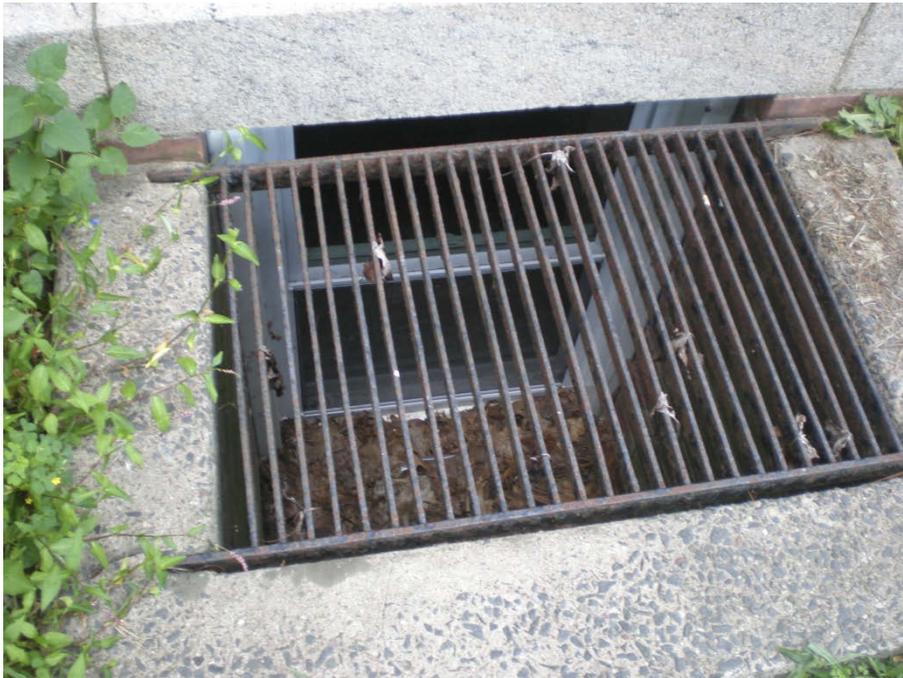
Metal Grate
Sample 2370

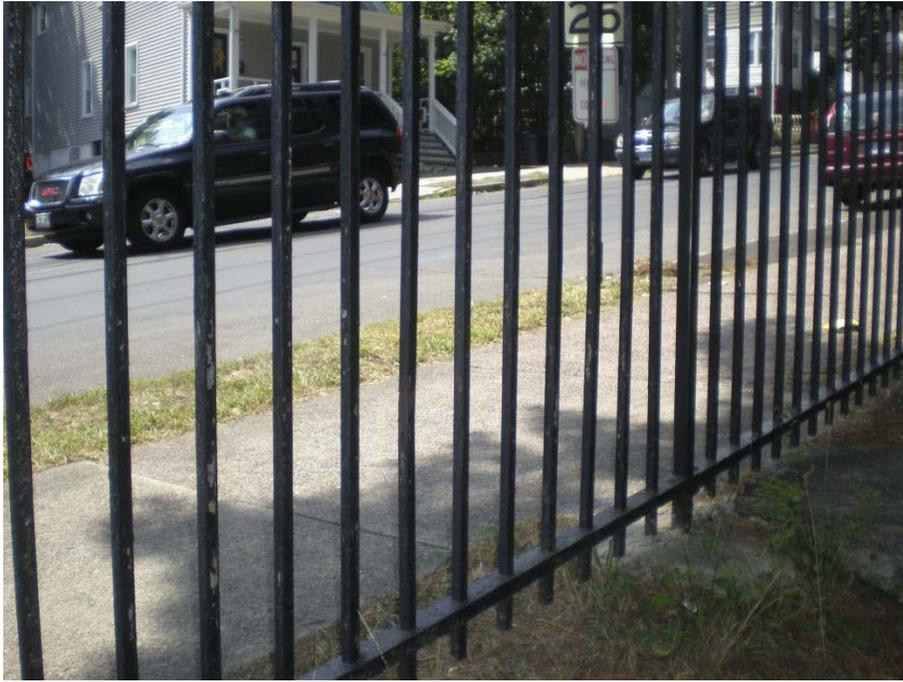
Metal Fence
Sample 2372
