LOCATION: VA HOSPITAL BUILDING 14 - WEST HAVEN, CT/FIRST FLOOR

### Representative Photographs of ACM

Representative Photographs  
of Non-Intact Lead Containing Paint  
Greater than or Equal to 1.0 mg/cm<sup>2</sup>

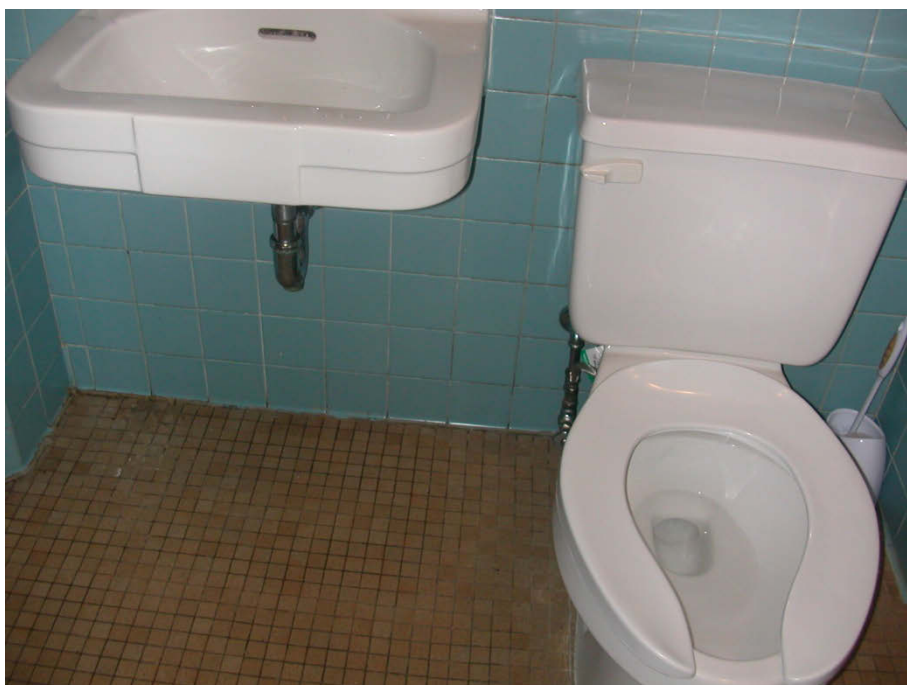
Flooring Caulk  
Sample 3A

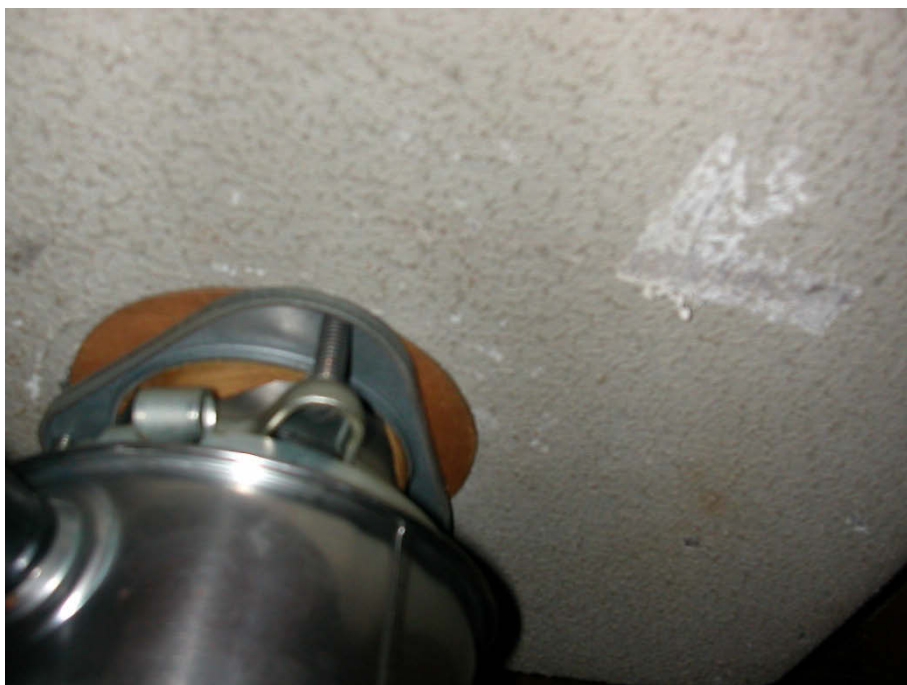
Sink Under Coating  
Sample 8A

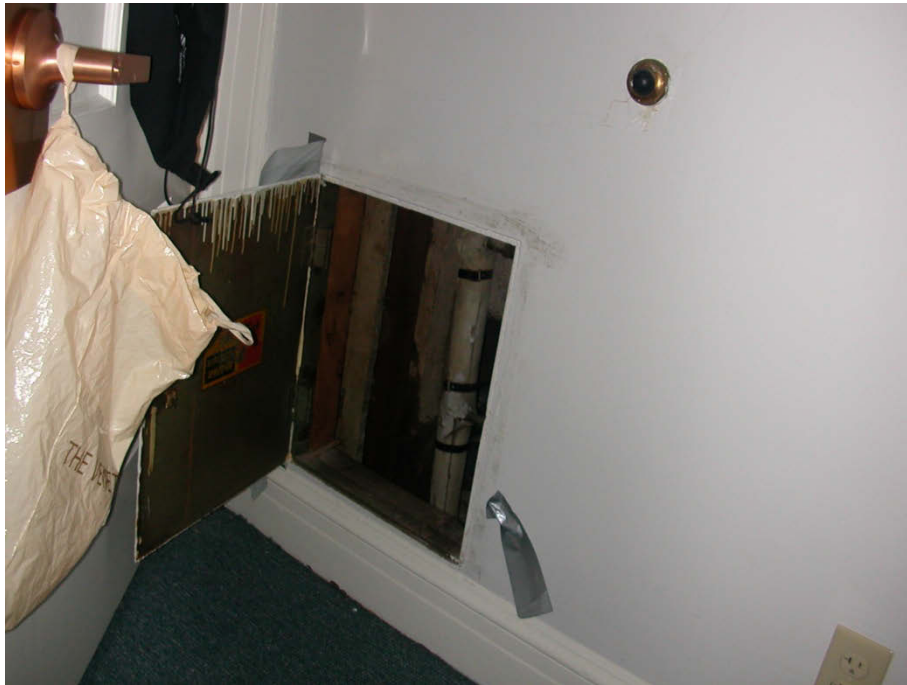
Pipe Joint Insulation  
Sample 9A

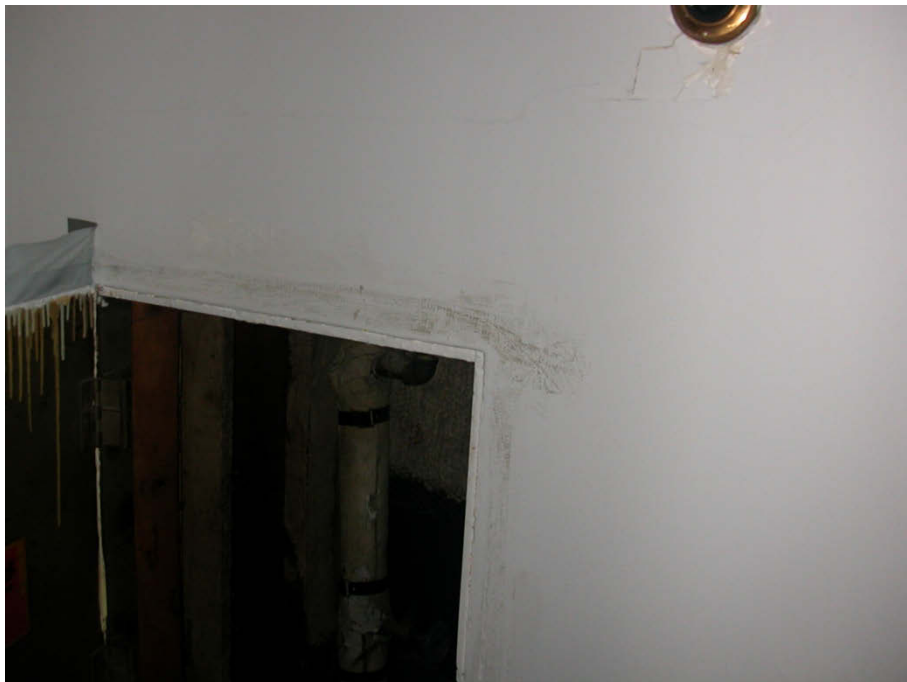
Corrugated Pipe Insulation  
Sample 12A

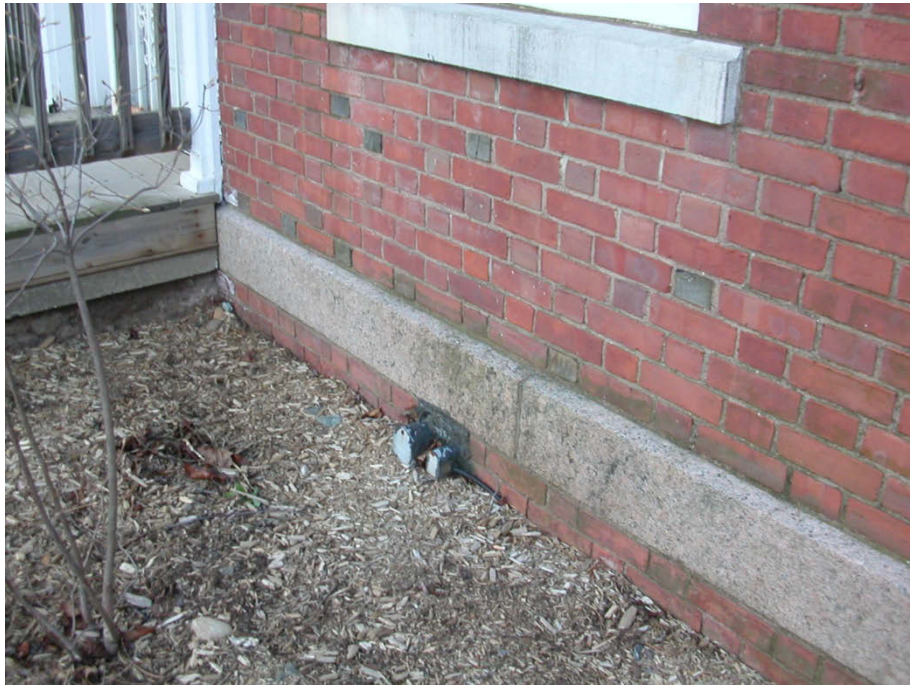
Black Electrical Conduit Caulk  
Sample 29A

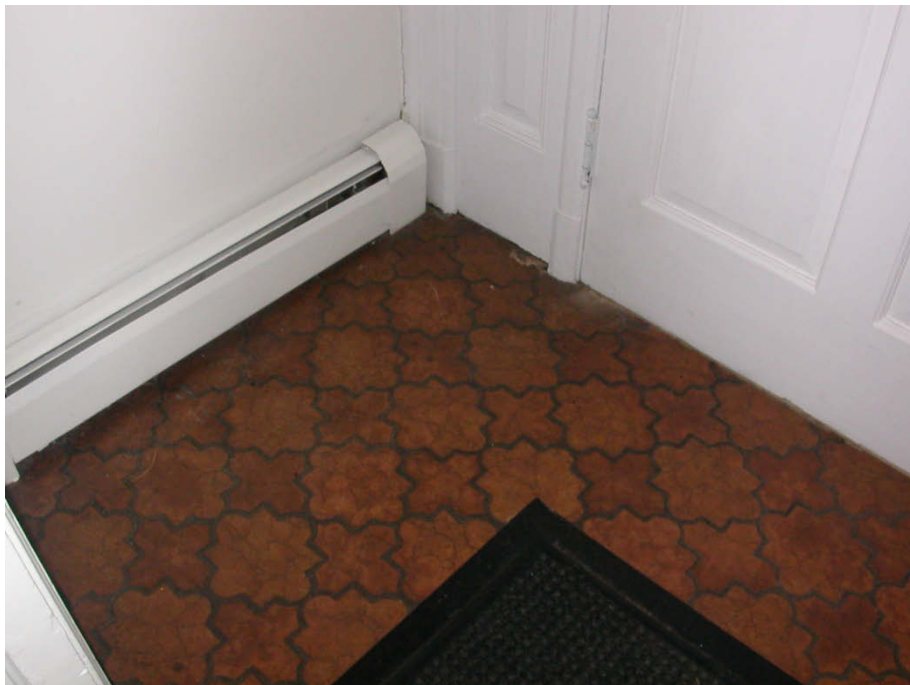
Brown Moroccan Linoleum  
Sample 35A

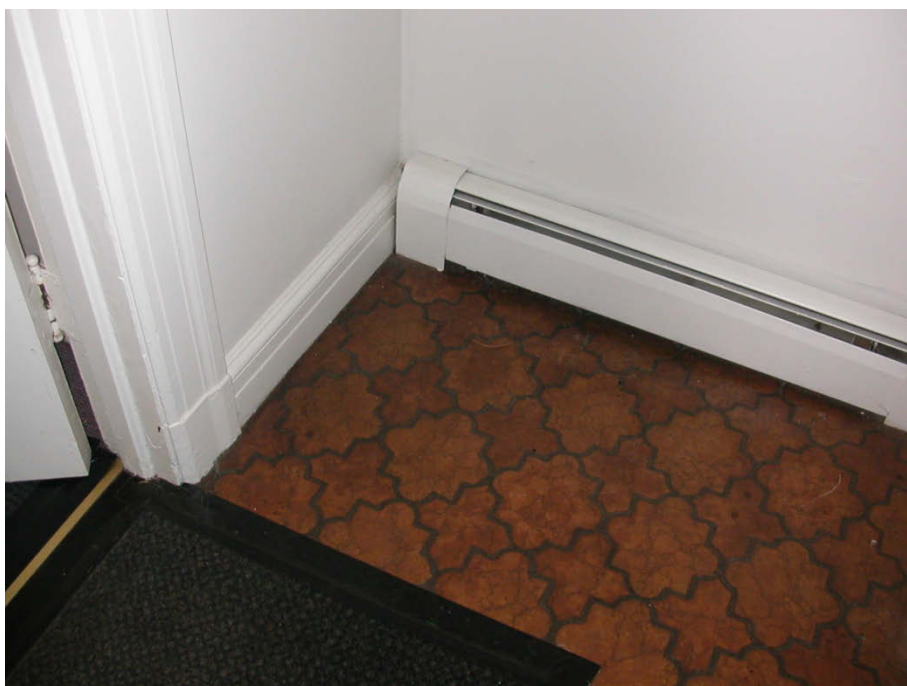
Felt Under Linoleum  
Sample 36A

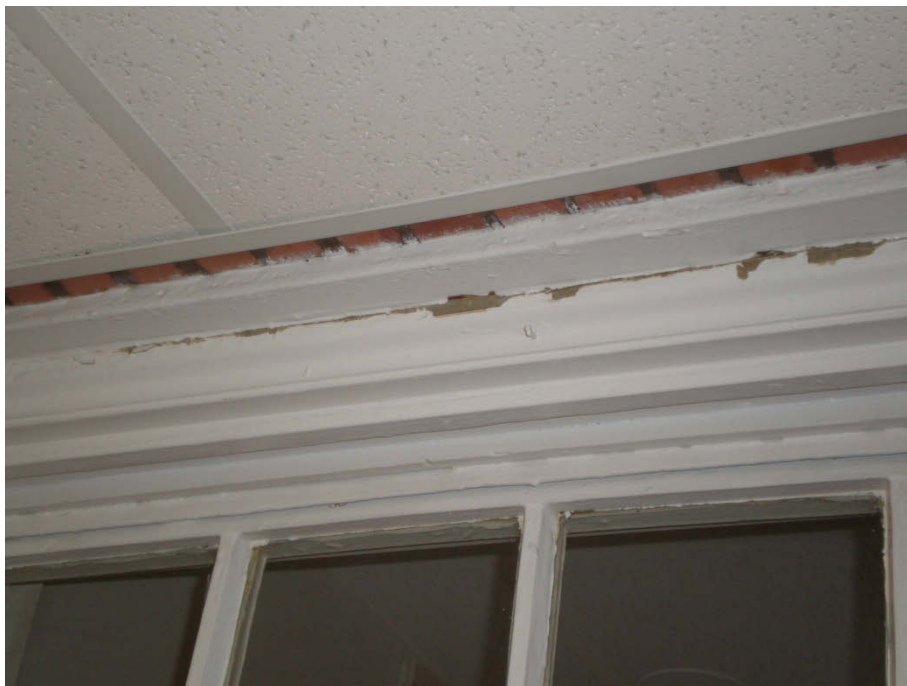
Metal Window Lintel  
Sample 2175

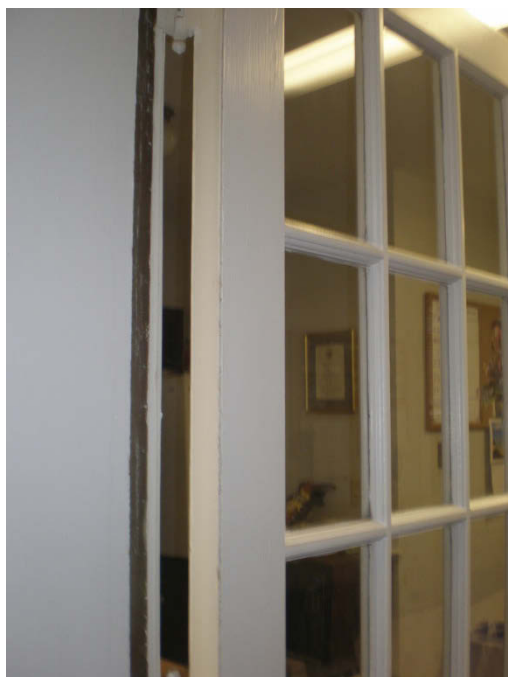
Wood Door  
Sample 2180

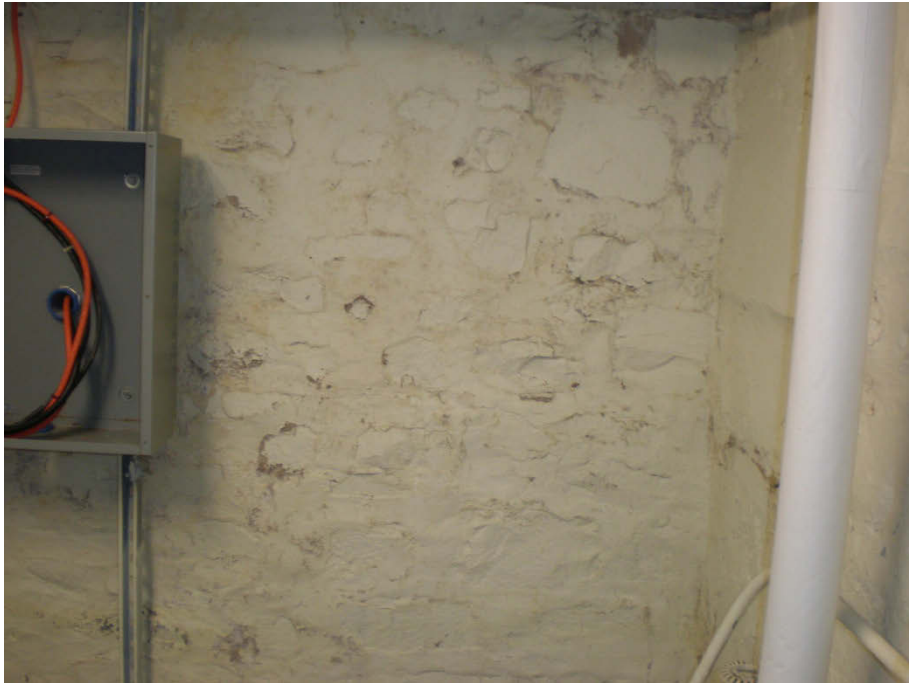
Stone Wall  
Sample 2315

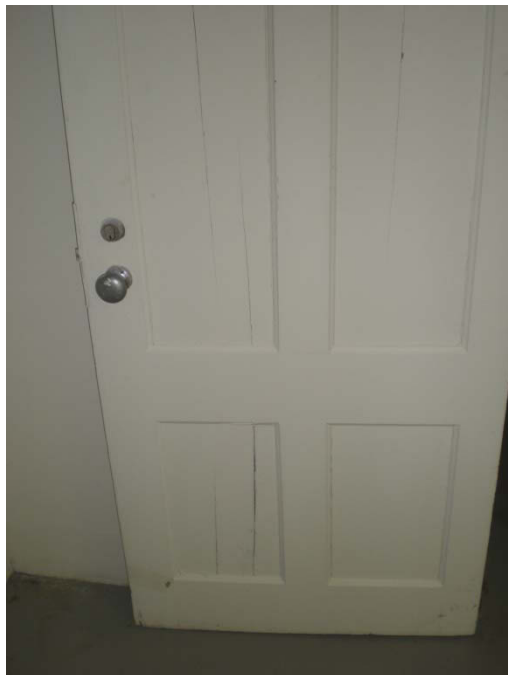
Wood Door  
Sample 2332

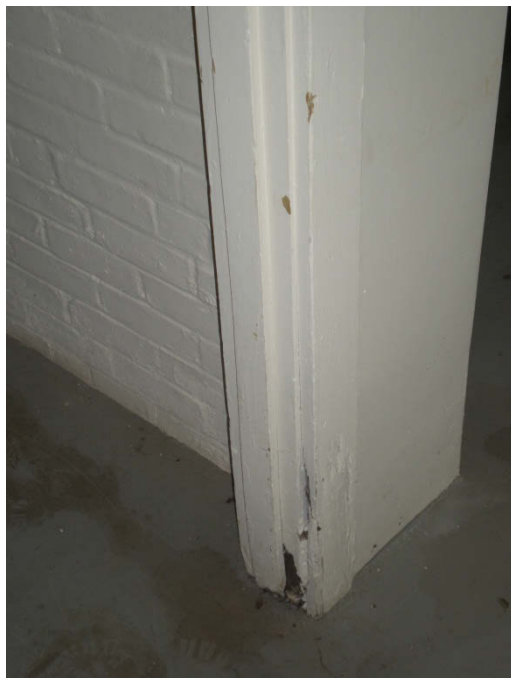
Wood Door Casing  
Sample 2333

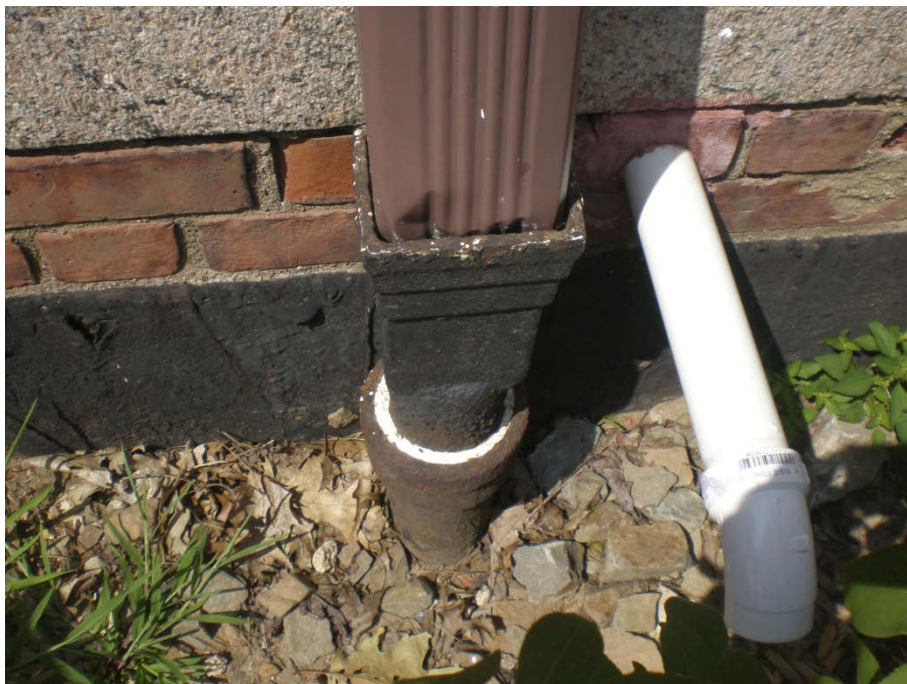
Metal Downspout  
Sample 2366

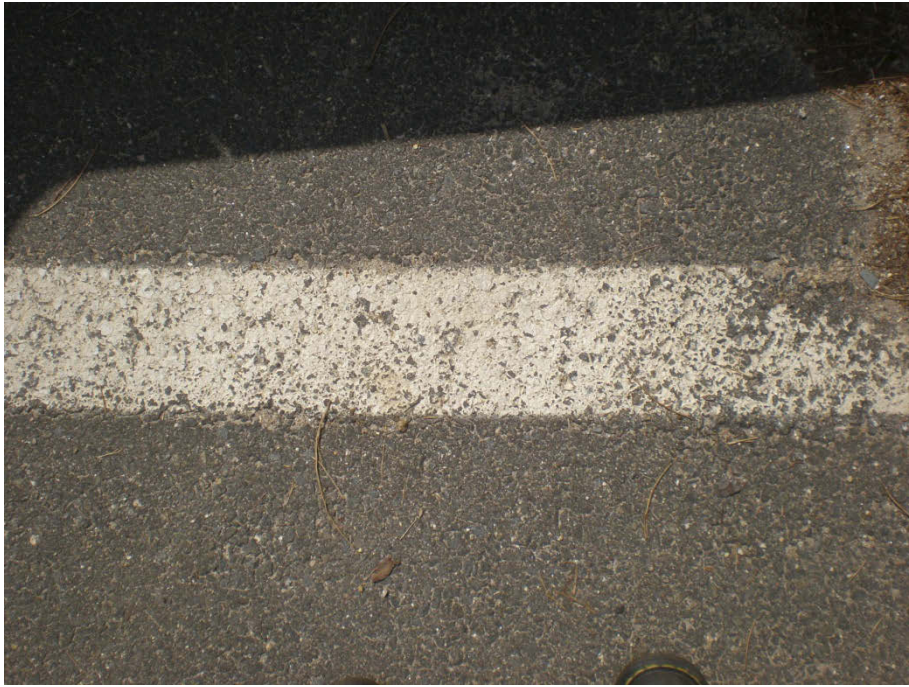
Asphalt Walk Stripe  
Sample 2369

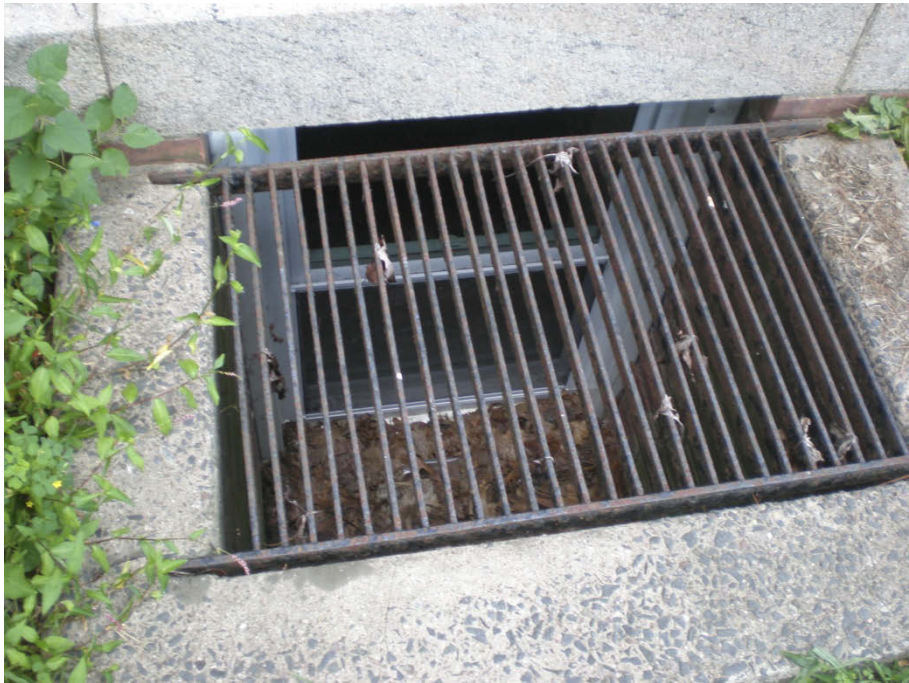
Metal Grate  
Sample 2370

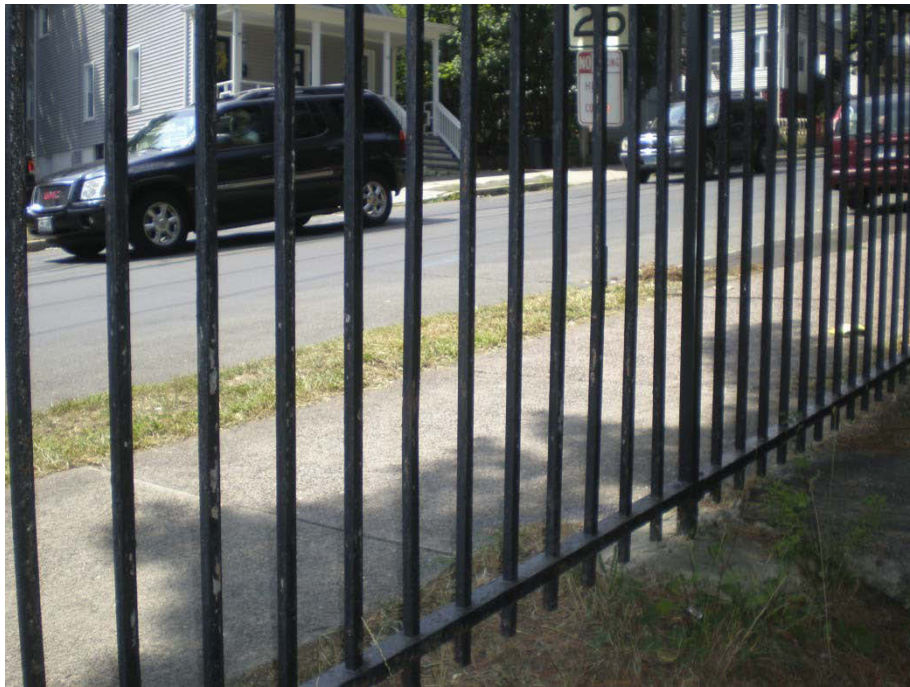
Metal Fence  
Sample 2372
