LOCATION: VA HOSPITAL BUILDING 14 - WEST HAVEN, CT/FIRST FLOOR

### Representative Photographs of ACM

Representative Photographs  
of Non-Intact Lead Containing Paint  
Greater than or Equal to 1.0 mg/cm<sup>2</sup>

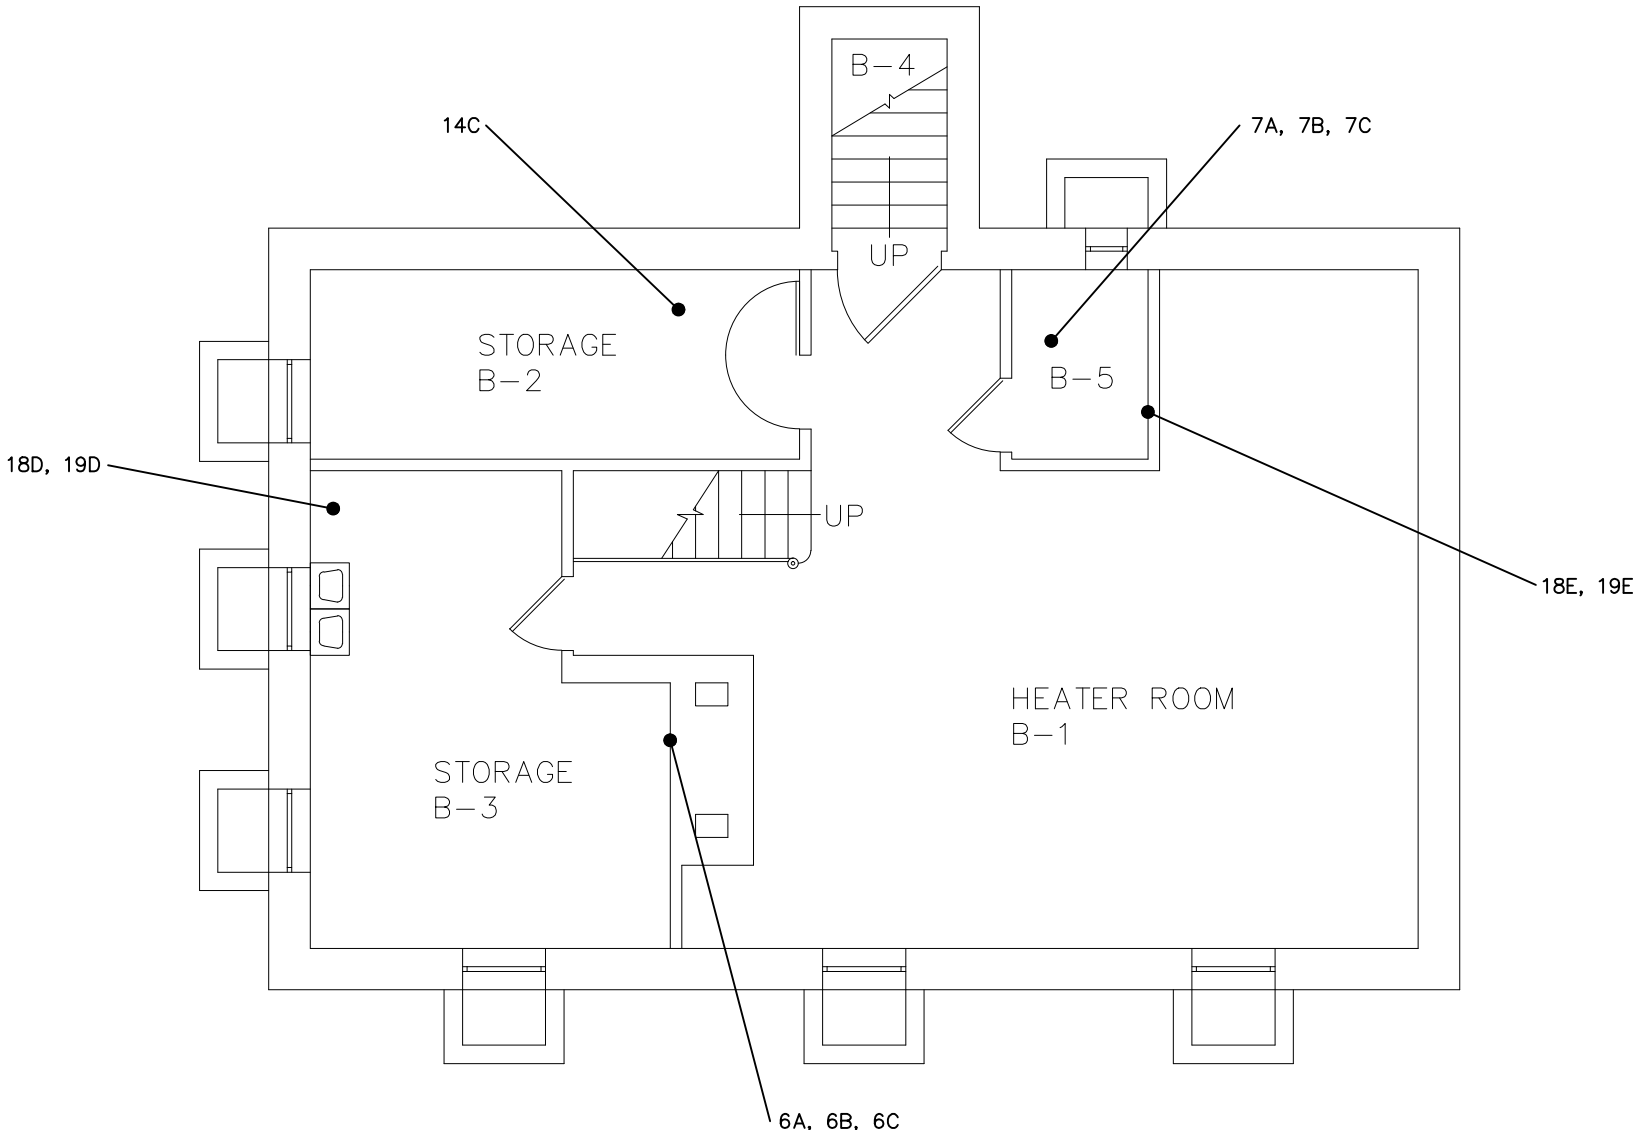
Drawing Title BUILDING 14 Floor BASEMENT	Project Title ASBESTOS SURVEY			DATE SEPTEMBER 2011	
				PROJ. NO.	
	Building Number 14	CHECKED JL	DRAWN JL	DWG. NO. 1	
SCALE: NOT TO SCALE	Location WEST HAVEN			Dwg. 1 OF 1

- 1,2 APPROXIMATE SAMPLE LOCATION
- 25\* SAMPLE GREATER THAN 1% ASBESTOS
- 25\*\* STOP POSITIVE SAMPLE FOR ASBESTOS
- 25 NO ASBESTOS DETECTED (NAD)

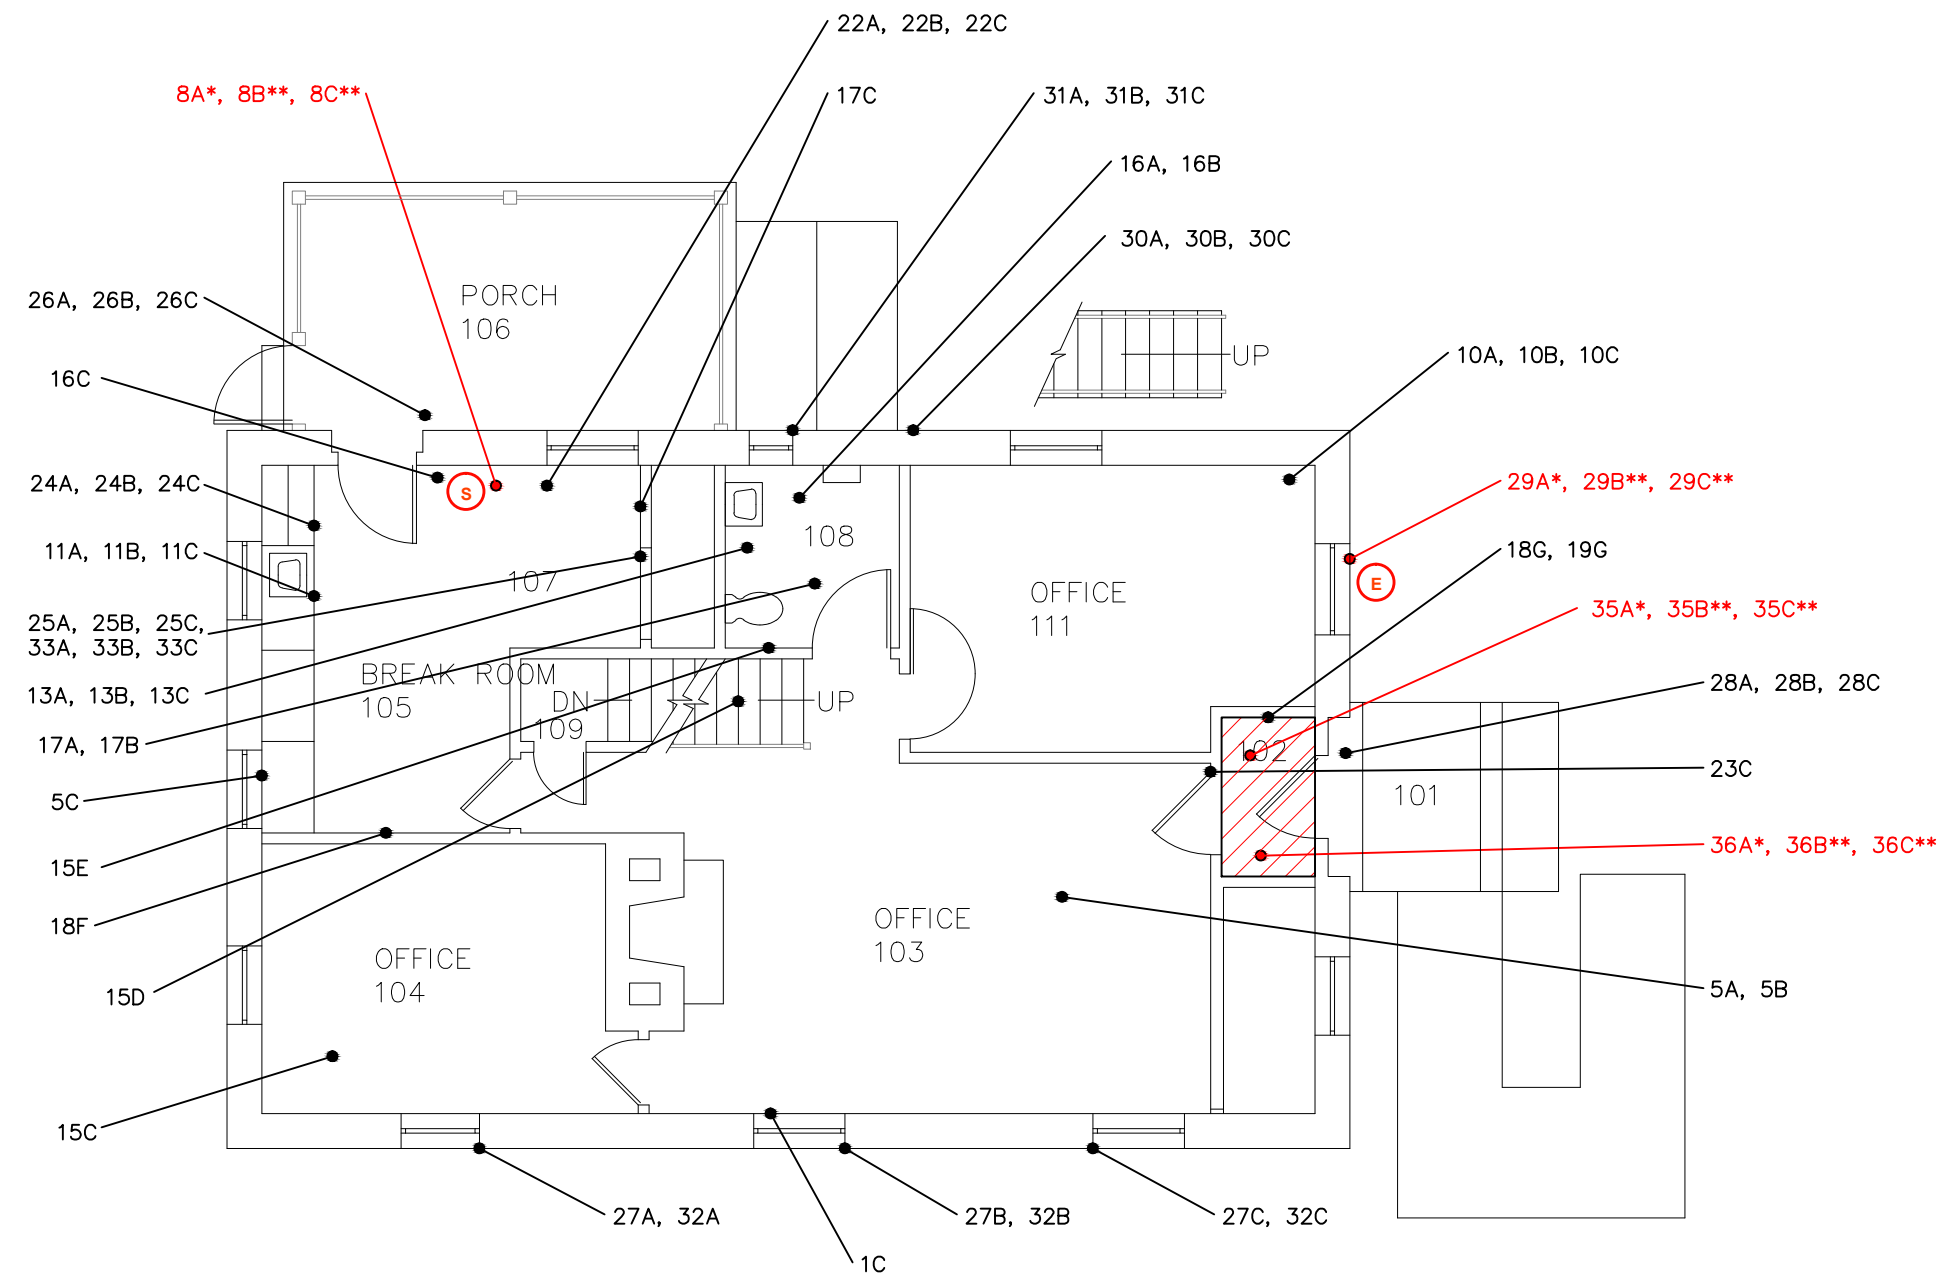
Floor FIRST FLOOR			PROJ. NO.	
	Building Number 14	CHECKED JL	DRAWN JL	
SCALE: NOT TO SCALE	Location WEST HAVEN		DWG. NO. 2 Dwg. 1 OF 1

- 1,2 \ APPROXIMATE SAMPLE LOCATION
- 25\* SAMPLE GREATER THAN 1% ASBESTOS
- 25\*\* STOP POSITIVE SAMPLE FOR ASBESTOS
- 25 NO ASBESTOS DETECTED (NAD)
-

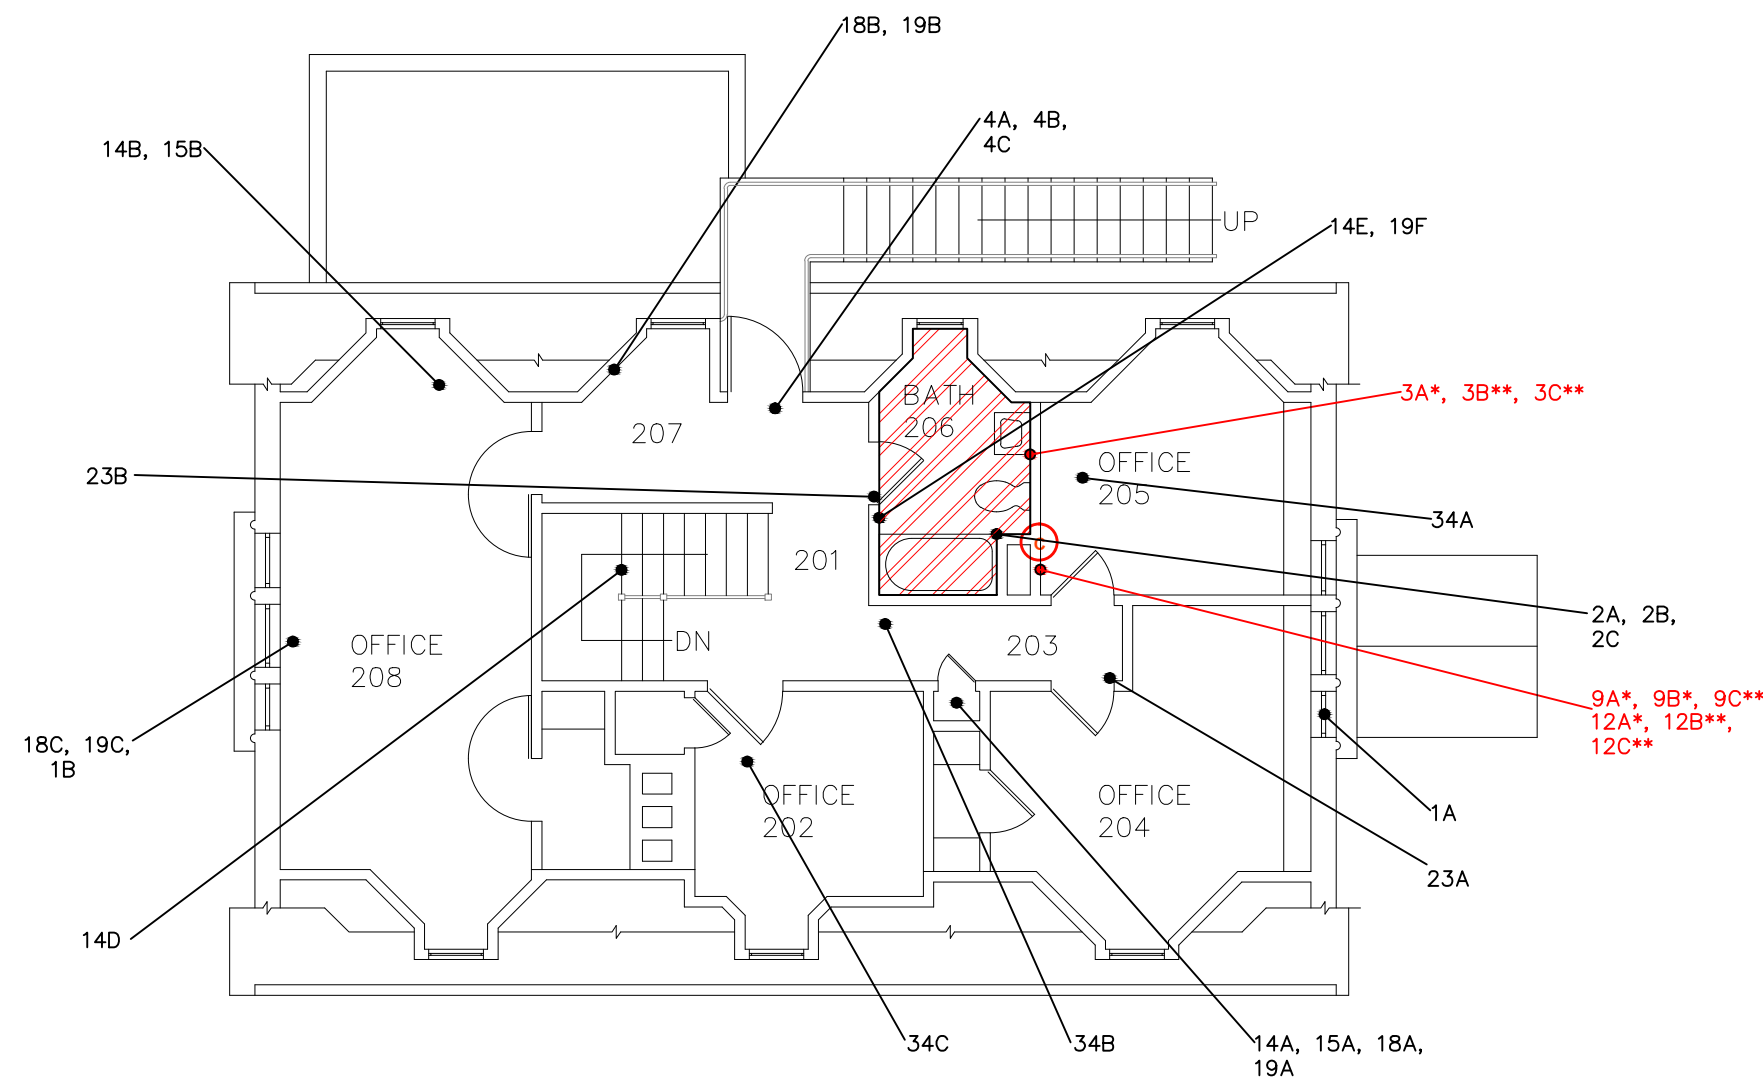
- 1,2 APPROXIMATE SAMPLE LOCATION
- 25\* SAMPLE GREATER THAN 1% ASBESTOS
- 25\*\* STOP POSITIVE SAMPLE FOR ASBESTOS
- 25 NO ASBESTOS DETECTED (NAD)
- [Red Hatched Box] ACM CAULKING ON FLOOR
- [Red Circle with C] ACM PIPE & FITTING INSULATION IN CHASE

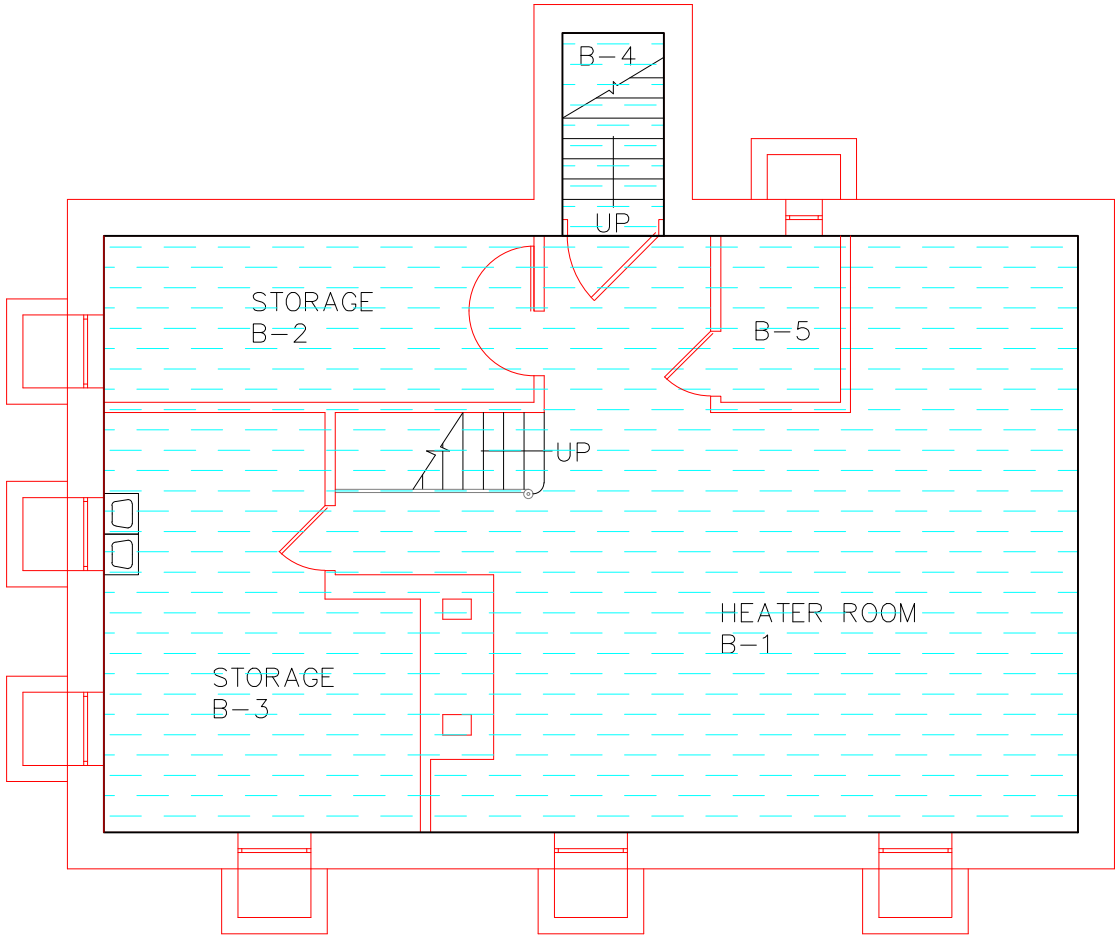
Drawing Title BUILDING 14	Project Title LEAD SURVEY		DATE SEPTEMBER 2011	
Floor BASEMENT			PROJ. NO.	
	Building Number 14	CHECKED JL	DRAWN JL	
	Location WEST HAVEN		DWG. NO. 4	
SCALE: NOT TO SCALE			Dwg. 1 OF 1

PLEASE SEE THE SAFETY OFFICE PRIOR TO PERFORMING MAINTENANCE/RENOVATION ACTIVITIES ON ANY OF THE FOLLOWING COMPONENTS IN HATCHED AREAS.		
These Building Components Depicted in Red Are Assumed To Contain Lead Containing Paint (LCP) at Greater Than 0.1 mg/cm <sup>2</sup> unless otherwise determined.		
COMPONENT	SUBSTRATE	SYMBOL
WALL	BRICK, PLASTER, STONE, WOOD

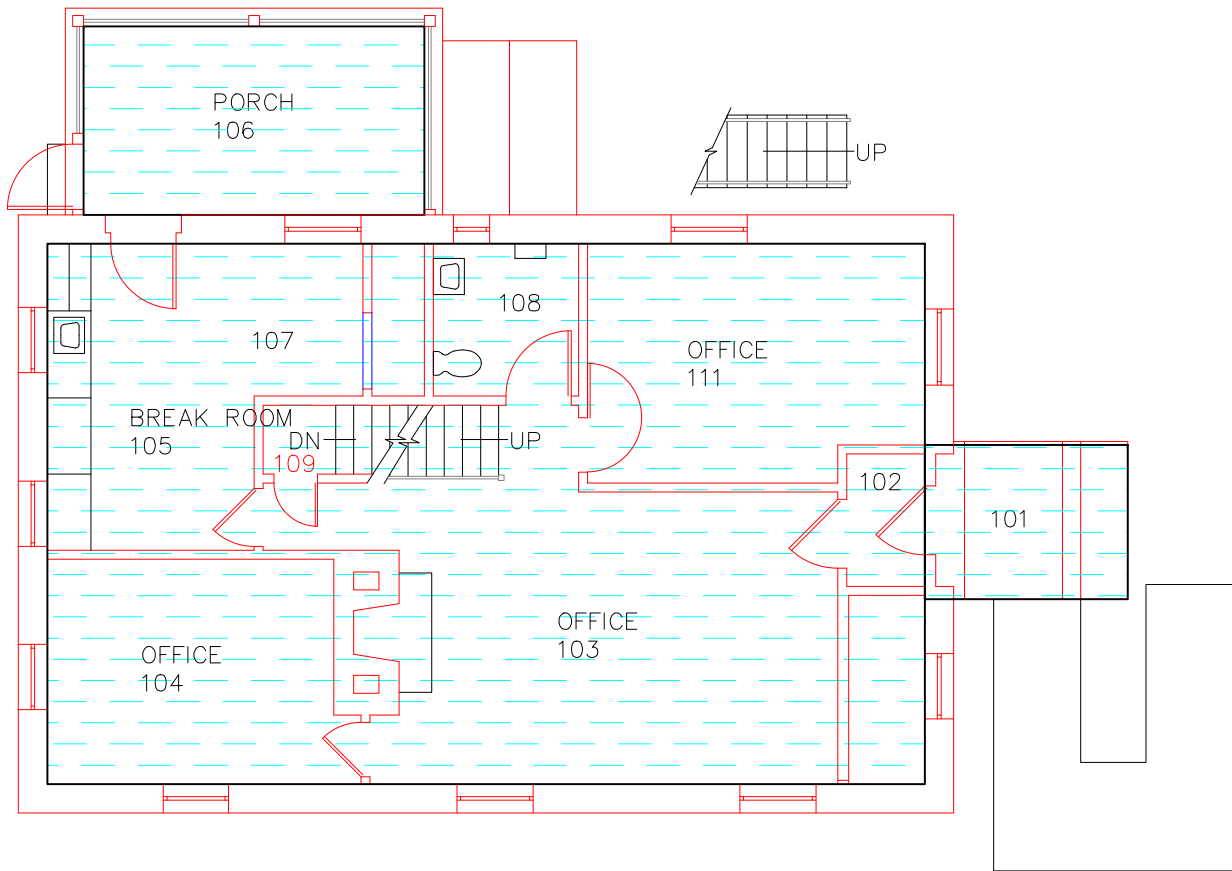
Drawing Title BUILDING 14	Project Title LEAD SURVEY	DATE SEPTEMBER 2011		
Floor FIRST FLOOR		PROJ. NO.		
	Building Number 14	CHECKED JL		DWG. NO. 5
	Location WEST HAVEN	DRAWN JL		Dwg. 1 OF 1
SCALE: NOT TO SCALE

These Building Components Depicted in Red Are Assumed To Contain Lead Containing Paint (LCP) at Greater Than 0.1 mg/cm<sup>2</sup> unless otherwise determined.

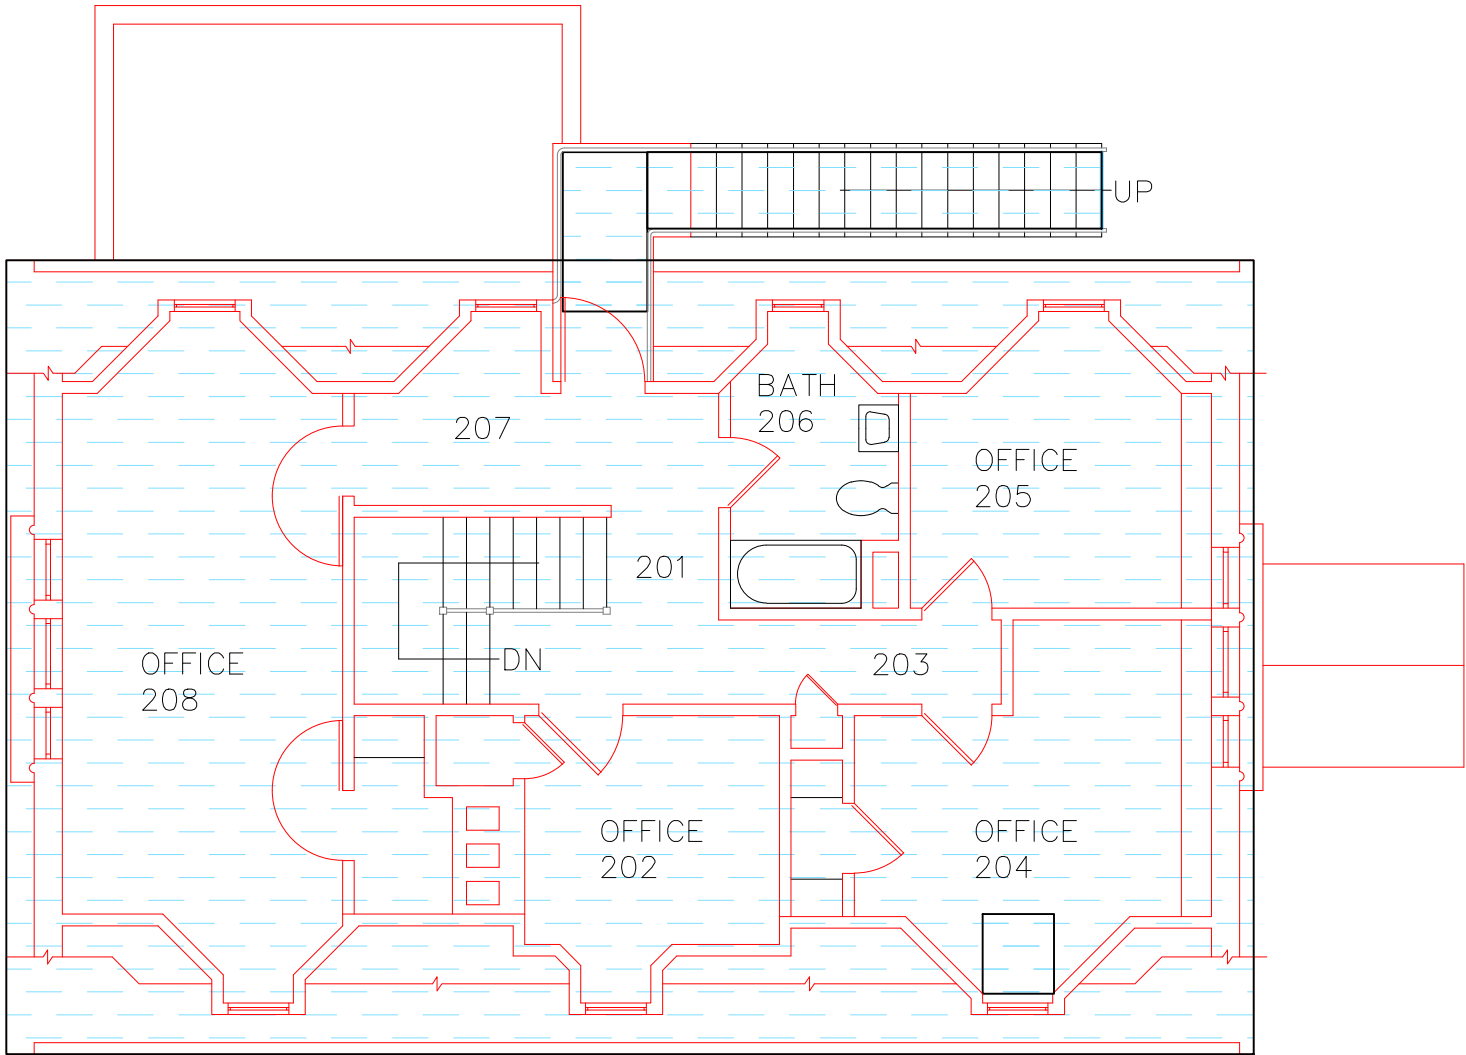
These Building Components Depicted in Red Are Assumed To Contain Lead Containing Paint (LCP) at Greater Than 0.1 mg/cm<sup>2</sup> unless otherwise determined.
